Flexible Grout Restores Reservoirs to Service

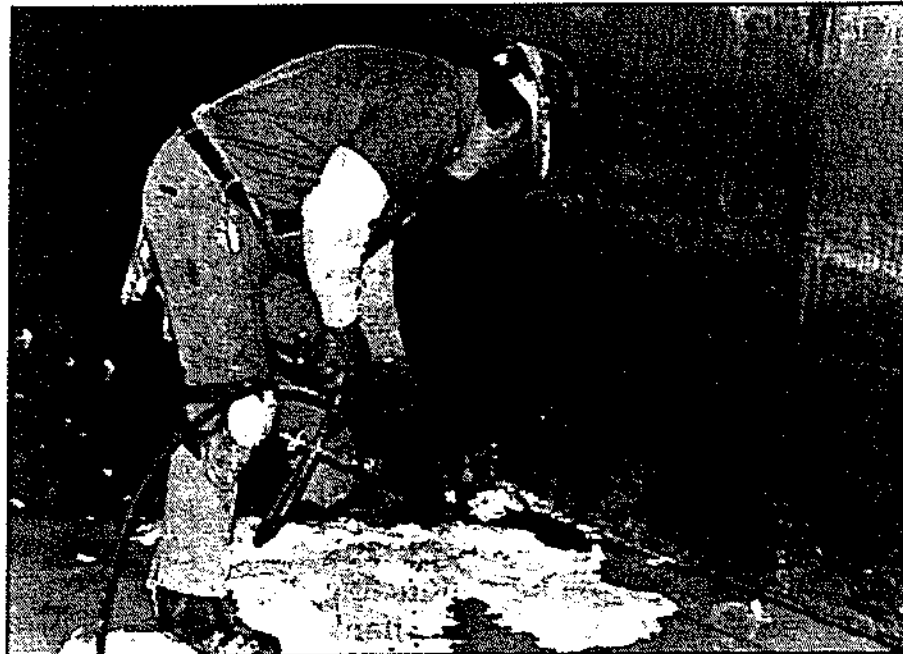
Liquid grout injected into cracked concrete reservoirs keeps the drinking water in and the groundwater out.

After the damaged tank was empty, a two-man crew drilled 5/8-in.-diameter holes at strategic locations at angles so they intercepted cracks or joints deep below or behind the surface of the concrete. Injection packers were then inserted into the drilled holes, and liquid grout was pumped through the packers and down the drilled holes. When the grout meets water or moisture, it begins to expand with an outward pressure of up to 7 psi and find its way into or behind the smallest crack.

The grout attains initial set and becomes an impermeable closed-cell plastic within just a few minutes. On the job site, the contractor uses a substance called an accelerator to control
